Stains - Identification and Prevention

Abstract: This *Technical Note* provides descriptions and photographs that aid in identifying efflorescence and stains on brickwork. It includes information on stain composition, factors that influence their occurrence, and stain prevention.

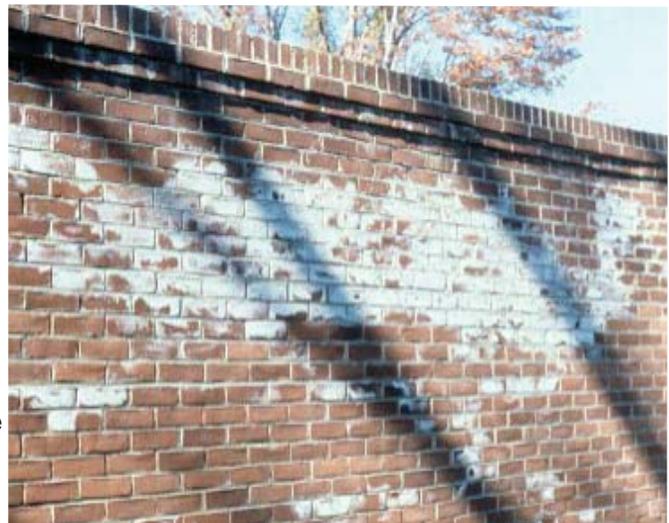
Efflorescence is normally a harmless deposit of water-soluble, white salt crystals, as shown in [Photo 1](#). In some instances efflorescence may appear on mortar joints as shown in [Photo 2](#). Efflorescence may appear in limited areas on the surface of brickwork as shown in [Photo 3](#) or, in extreme cases, cover the entire brickwork surface.

Photo 1
Efflorescence

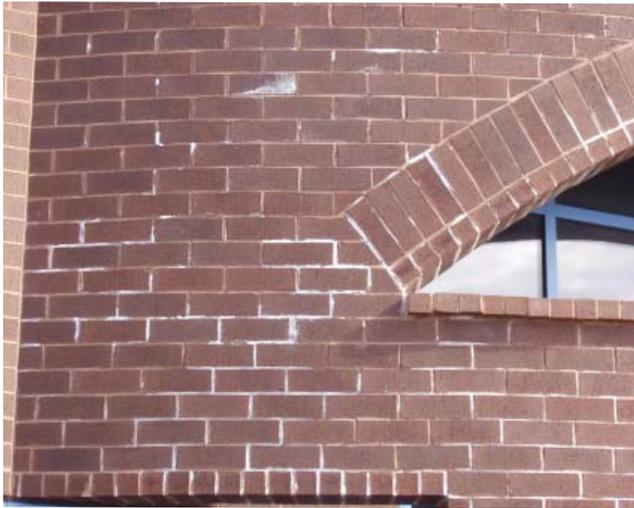
Photo 2
Efflorescence on Mortar Joints

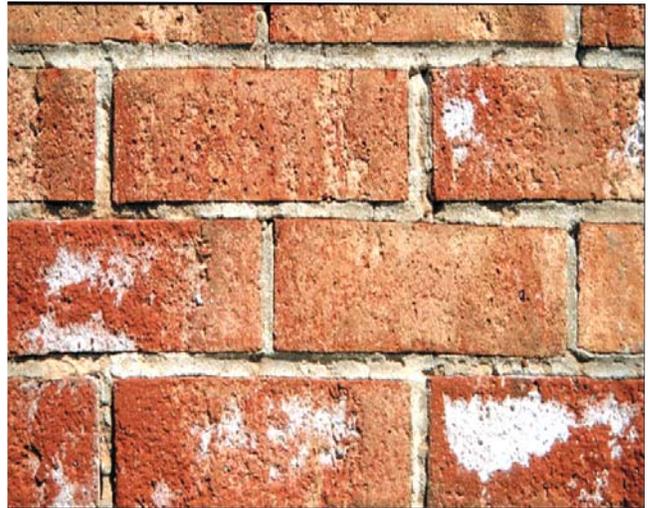
Photo 3
Efflorescence in Limited Areas

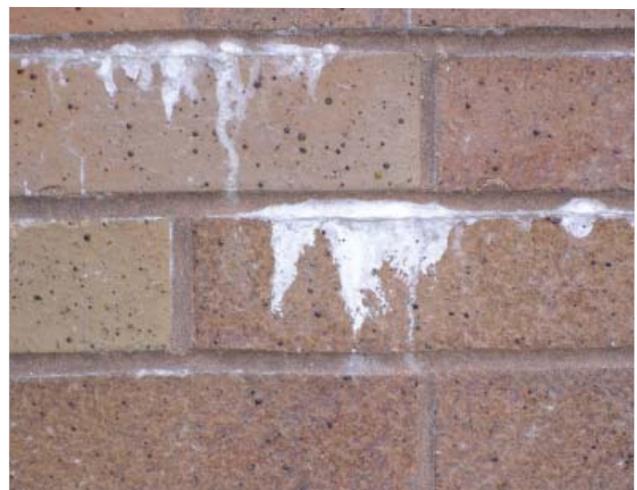
Calcium carbonate deposits, sometimes referred to as “lime run,” usually appear as white or gray, crusty formations originating from a spot and running down the face of the wall, as shown in [Photo 4](#). However, the term “lime run” is misleading since the stain is not a direct result of the lime component in the mortar. In fact, hydrated lime actually helps to reduce the risk of lime run. Lime run nearly always occurs at a small hole or opening or hairline crack in the face of the brick masonry, as shown in [Photo 5](#).

Photo 5
Lime Run

Materials containing cement are sources of calcium compounds and are an integral component of or may be in contact with the brickwork. To reduce the possibility of lime run, excess water must be eliminated or the path must be disrupted. Once lime run begins, it is likely to continue until difficult to the water source is stopped.

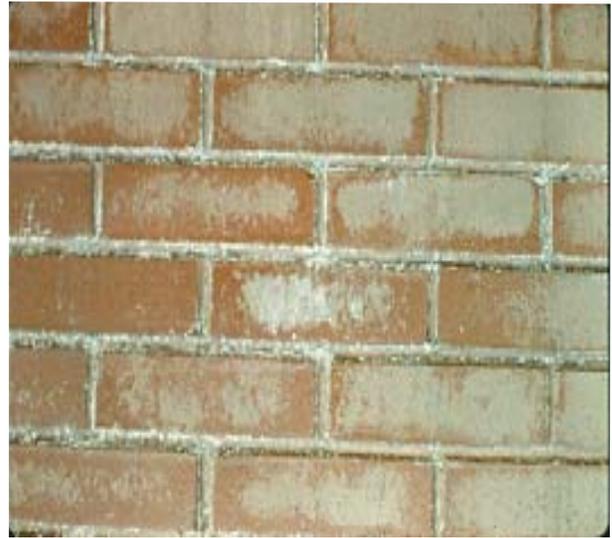
Silicate deposits, sometimes referred to as “white scum,” usually appear as white or gray discolorations on the face of brick masonry, as shown in [Photo 6](#). The discoloration may be present over the entire face of the brickwork or in smaller, irregularly shaped areas. White

A number of mechanisms may precipitate white scum on brickwork. White scum is typically related to the cleaning of brickwork with unbuffered hydrochloric (muriatic) acid solutions or inadequate pre-wetting or rinsing of the brickwork during cleaning.

Photo 6
White Scum

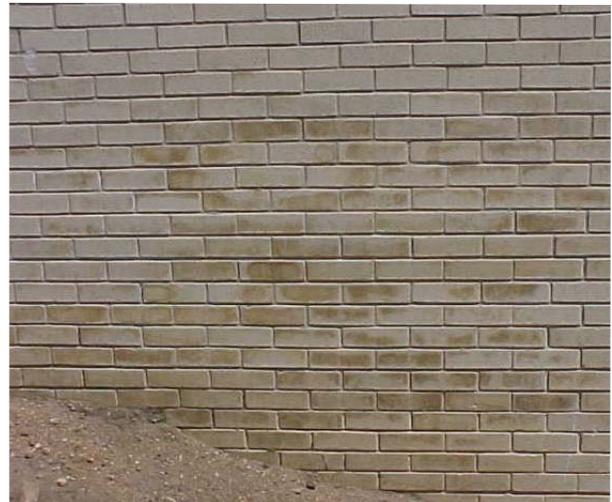
Some brick develop yellow or green salt deposits as shown in [Photos 7](#) (yellow) and [8](#) (green) when they come in contact with water or unbuffered hydrochloric (muriatic) acid. These stains are usually vanadium salts. They may be found on red, buff or white brick; however, they are more conspicuous on lighter-colored brick. The vanadium salts responsible for these stains originate in the raw materials used for the manufacture of the brick. The yellow and green stains are usually vanadyl salts, consisting of sulfates and chlorides, or hydrates of these salts.

Vanadium stains occur in a manner similar to efflorescence, except that vanadium oxide and sulfates are dissolved and result in a solution that may be quite acidic. As water evaporates from this solution at the surface of the brickwork, vanadyl salts are deposited. The chloride salts of vanadium, such as vanadyl chloride, may form as a result of washing with unbuffered hydrochloric (muriatic) acid or excessive moisture exposure. [Ref. 2]

Photo 7
Yellow Vanadium Stain

Preventing vanadium stains is important, since they can be difficult to remove and improper cleaning efforts may result in a brown, insoluble deposit. To minimize the potential for vanadium stains, the following steps are recommended:

- Store brick off the ground and under non-staining protective covers.
- Never use or permit the use of highly-concentrated, unbuffered hydrochloric (muriatic) acid solutions to clean light-colored brick.
- Seek and follow the cleaning recommendations of the brick manufacturer.

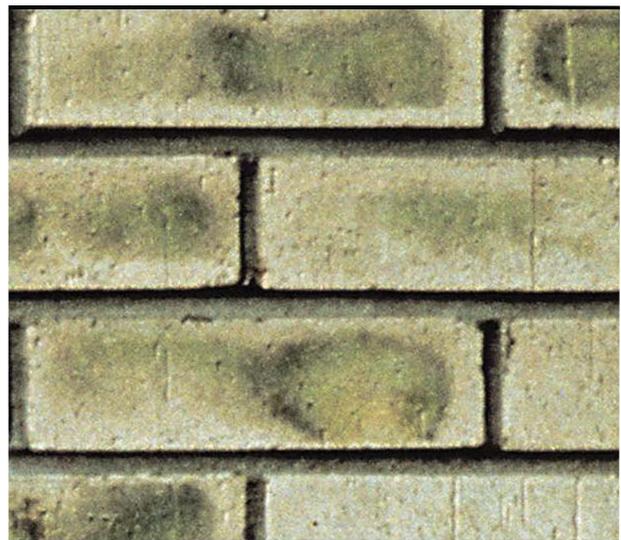
Photo 8
Green Vanadium Stain

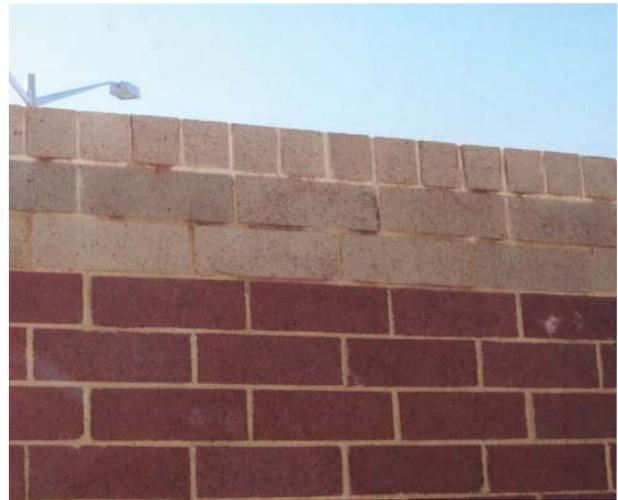
Under certain conditions, tan, brown, or occasionally gray staining may occur on the mortar joints of brickwork as shown in [Photo 9](#). Occasionally, a brown stain will streak down onto the faces of the brick as shown in [Photo 10](#). This type of stain is the result of having a manganese oxide as a coloring agent in tan, brown, black or gray brick and its reaction to an acid.

Manganese staining is closely related to efflorescence, since it is the sulfate and chloride salts of manganese that travel to the surface of the brickwork. When the solution reaches the mortar joints, the salts are neutralized by the cement or lime in the mortar producing insoluble manganese hydroxide. The manganese hydroxide precipitate is deposited on the mortar joint and when dry converts to brown manganese tetroxide resulting in the stain. [Ref. 2]

Photo 9
Manganese Stain

Unbuffered hydrochloric (muriatic) acid should not be used to clean tan, brown, black or gray brick. Proprietary cleaning compounds are available for cleaning brick containing manganese. Test for effectiveness and follow the advice of the brick manufacturer.

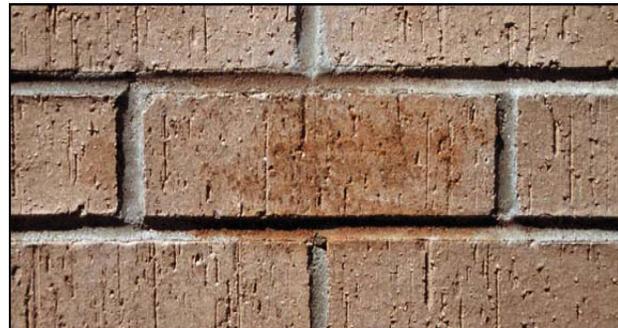
Photo 10
Manganese Stain

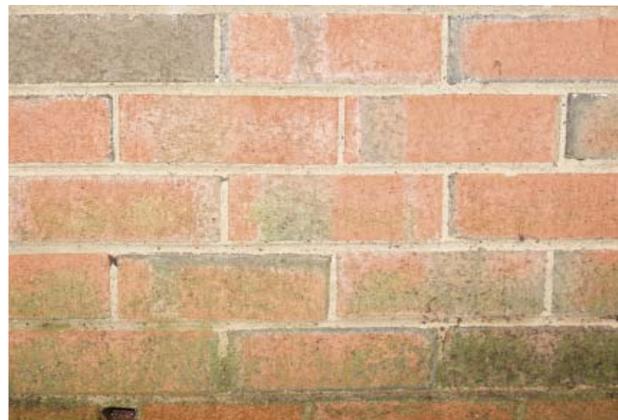
Other stains affecting brickwork are generally caused by external sources such as pollution, organic growth, runoff or others. Usually, the source or composition of these stains is obvious. Organic stains, as shown in [Photo 11](#), can include algae, mold, or other organisms. Certain materials above or adjacent to brickwork such as copper ([Photo 12](#)), bronze, aluminum, synthetic stucco or paint ([Photo 13](#)) can stain brickwork surfaces. In addition, externally caused stains such as hard water from sprinkler systems can effect brickwork ([Photo 14](#)). The color and appearance should be considered during identification. Laboratory or field tests can determine the stain composition and assist in proper identification. Once the correct identification is made, the appropriate method to clean the brickwork can be implemented.

Photo 11
Organic Stain

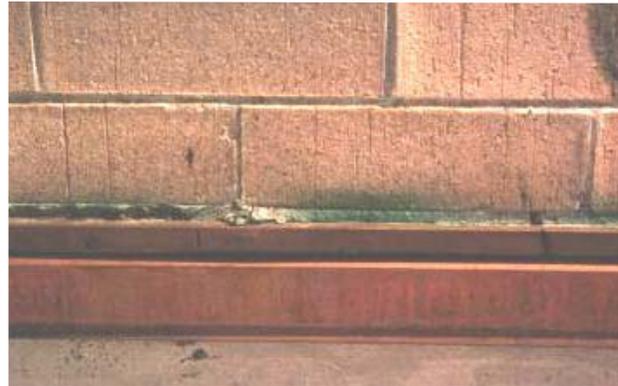
Photo 12
Stain from Copper

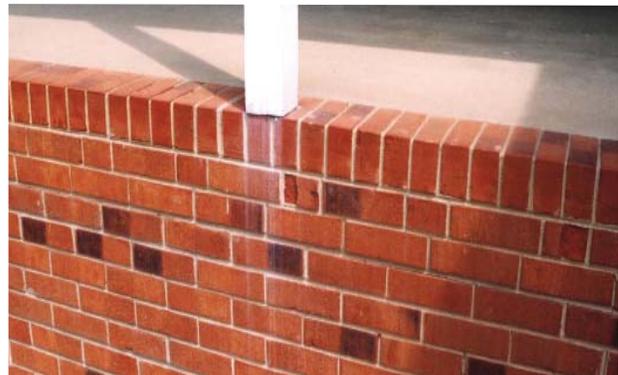
Photo 13
Runoff Stain from Paint

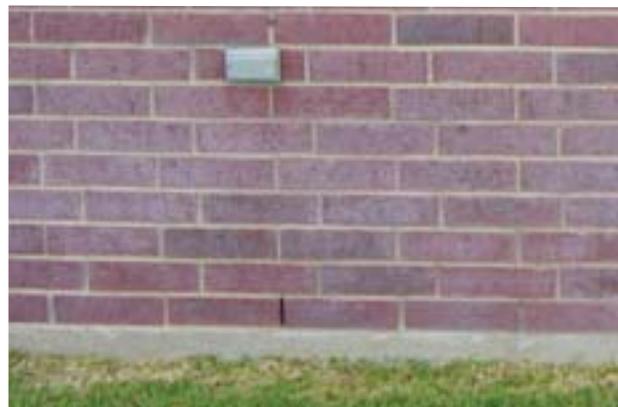
Photo 14
Hard Water Stain

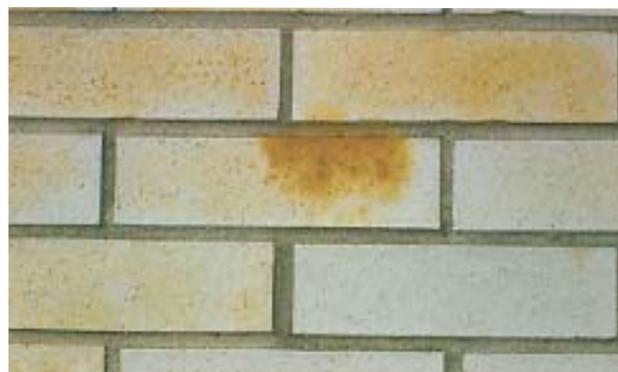
Rust-colored stains may actually be corrosion, as shown in [Photo 15](#). Such stains can be the result of

corrosion of wall ties or joint reinforcement in or adjacent to the brickwork. The use of improper mortar additives or ingredients, placement of wall ties or joint reinforcement with inadequate cover, welding splatter on the brick, or the corrosion of a material placed on the brick cube or pile prior to being laid in the brickwork can all attribute to these stains.

Photo 15
Rust Stain
